**RUNWAY DAMAGE  
KABRIT AIRFIELD, EGYPT  
30-14N 032-29E**

NATIONAL PHOTOGRAPHIC  
INTERPRETATION CENTER

MISSION GR XA007, 4 NOVEMBER 1973

RUNWAY DAMAGE  
KABRIT AIRFIELD, EGYPT

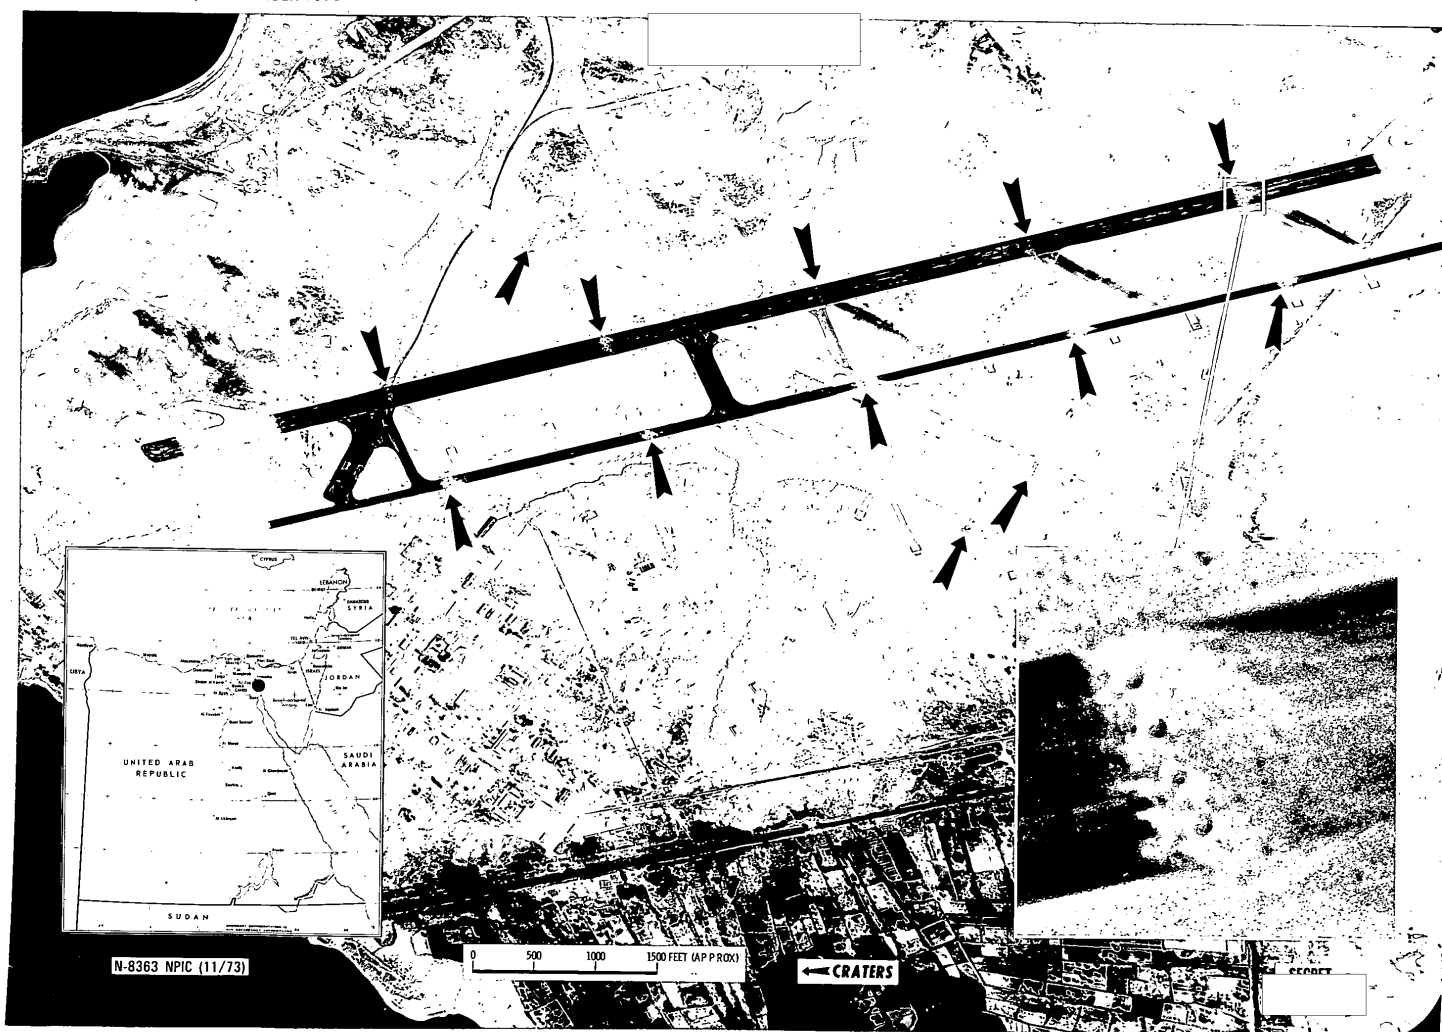
1. SIGNIFICANCE: RUNWAY DAMAGE FROM SET EXPLOSIVES  
OBSERVED AT KABRIT AIRFIELD, EGYPT.
2. LOCATION: KABRIT AIRFIELD IS  
ON THE SOUTH SIDE OF LITTLE BITTER  
LAKE, 3.2 NAUTICAL MILES (NM) EAST  
OF KASFAREET AIRFIELD  
AT 30-14-53N 032-29-32E.
3. MISSION READOUT: CRATERS CAUSED BY SET EXPLOSIVES  
INTERDICTED BOTH THE MAIN RUNWAY AND THE PARALLEL TAXIWAY  
AT FIVE POINTS. THE ALTERNATE RUNWAY HAD ALSO BEEN  
INTERDICTED AT TWO POINTS AND ITS PARALLEL TAXIWAY IN THE  
SAME MANNER. THE AIRFIELD WAS CRATERED AS EARLY AS
